DEPARTMENT OF TRANSPORTATION**DIVISION OF ENGINEERING SERVICES**

Contract #: 04-0120F4Cty: SF/ALA Rte: 80 PM: 13.2/13.9File #: 1.28**WELDING INSPECTION REPORT****Resident Engineer:** Pursell, Gary**Address:** 333 Burma Road**City:** Oakland, CA 94607**Report No:** WIR-015497**Date Inspected:** 06-Jul-2010**Project Name:** SAS Superstructure**OSM Arrival Time:** 600**Prime Contractor:** American Bridge/Fluor Enterprises, a JV**OSM Departure Time:** 1500**Contractor:** American Bridge/Fluor Enterprises, a JV**Location:** Job Site

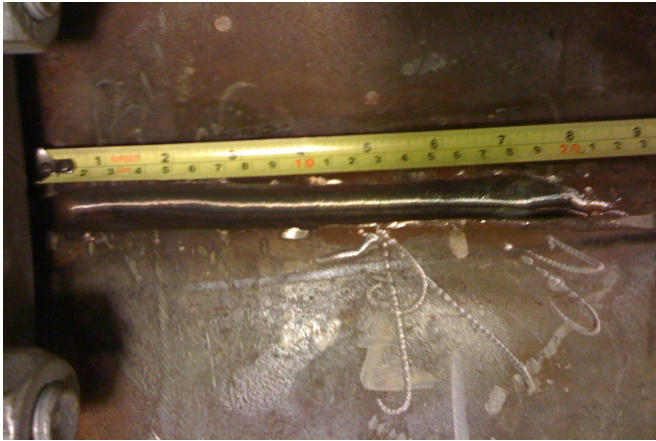
3E/4E-D

Upon the arrival of the QA Inspector it was noted the ABF welder Fred Kaddu was on site to perform excavations and weld repairs from previously rejected and indicated weld defects. The QA Inspector randomly observed the SE QC Inspector Jesse Cayabyab was present at the time of the excavations. The QA Inspector randomly observed the ABF welder Fred Kaddu begin excavating the ultrasonic testing (UT) reject. The QA Inspector randomly observed the QC Inspector performed magnetic particle testing of the excavated area. The QA Inspector noted no relevant indications were located at the time of the testing. The QA Inspector noted the Y dimension of the excavation was Y=0mm-205mm. The QA Inspector noted the dimensions of the excavations were 205mm X 20mm X 10mm deep (pictured below). The QA Inspector randomly observed the ABF welder begin welding the shielded metal arc welding (SMAW) repair of the excavation identified above. The QA Inspector randomly observed the ABF welder utilizing 1/8" E7018 Low Hydrogen electrodes with 128 Amps. The QA Inspector noted the SMAW parameters appeared to be in general compliance with ABF-WPS-D1.5-1000-Repair. The QA Inspector noted the above identified weld joint has 13 total weld repairs.
